The Gulf Curve Disaster

Photos from the Collection of Harold Usyk

Story by David Hamilton

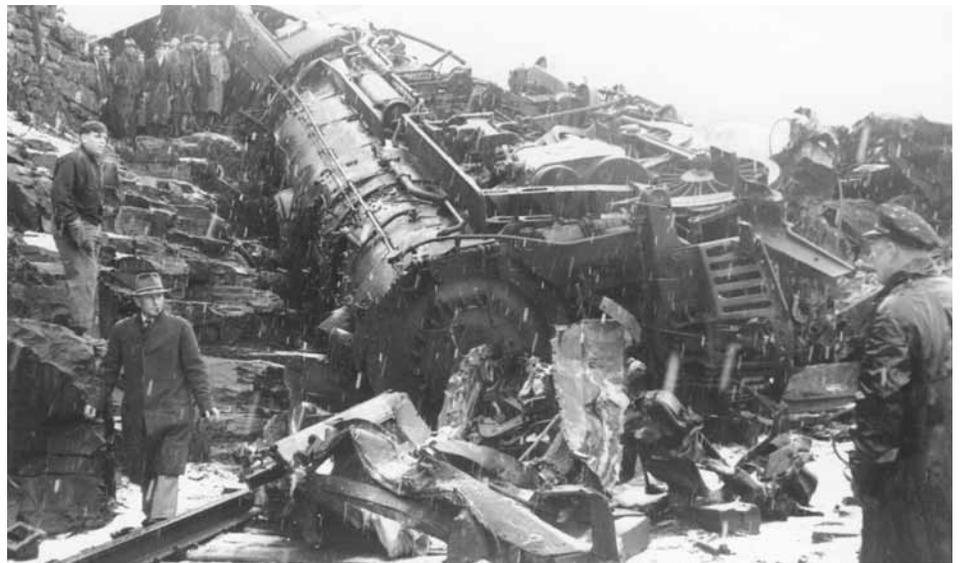
At top right, Engine 5315 lies against the rock outcrop that stopped its northward slide. At center, a view of the wreckage of the cars that piled up against it. At bottom right, while recovery efforts continue, workers begin to repair the track. Gregorka Photo Service of Little Falls, NY.

Rolling over on its right side, the engine slid across the two freight mains, until its momentum was checked by a small rock pinnacle that stood on the north side of the tracks. Sharp rock penetrated the firebox wrapper sheet, causing an explosion that blew out the crown sheet and grate bars, launching part of the ash pan across the river. The tender remained coupled and was deposited on top of the rocks.

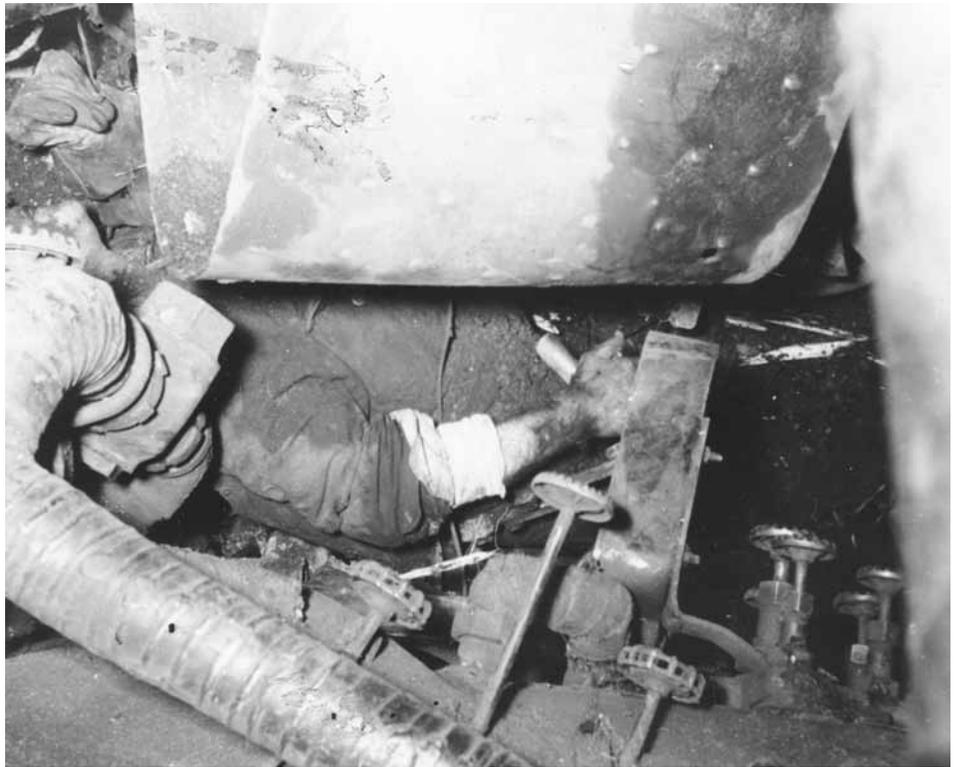
Above, in a scene reminiscent of railroad folk songs, the body of engineer Jesse Earl lies pinned in the wreckage, with his hand still on the throttle. Below, a steam crane begins the process of righting the derailed cars, some of which slid up East Main Street. Both photos by Gregorka Photo Service of Little Falls.

and others torn apart with their interior contents strewn about the tracks. The locomotive cab was crushed when it overturned and collided with the rocks, killing engineer Earl and fireman Smith. Road Foreman Bayreuther was seriously injured, but later recovered and was able to provide his account of the wreck to investigators.

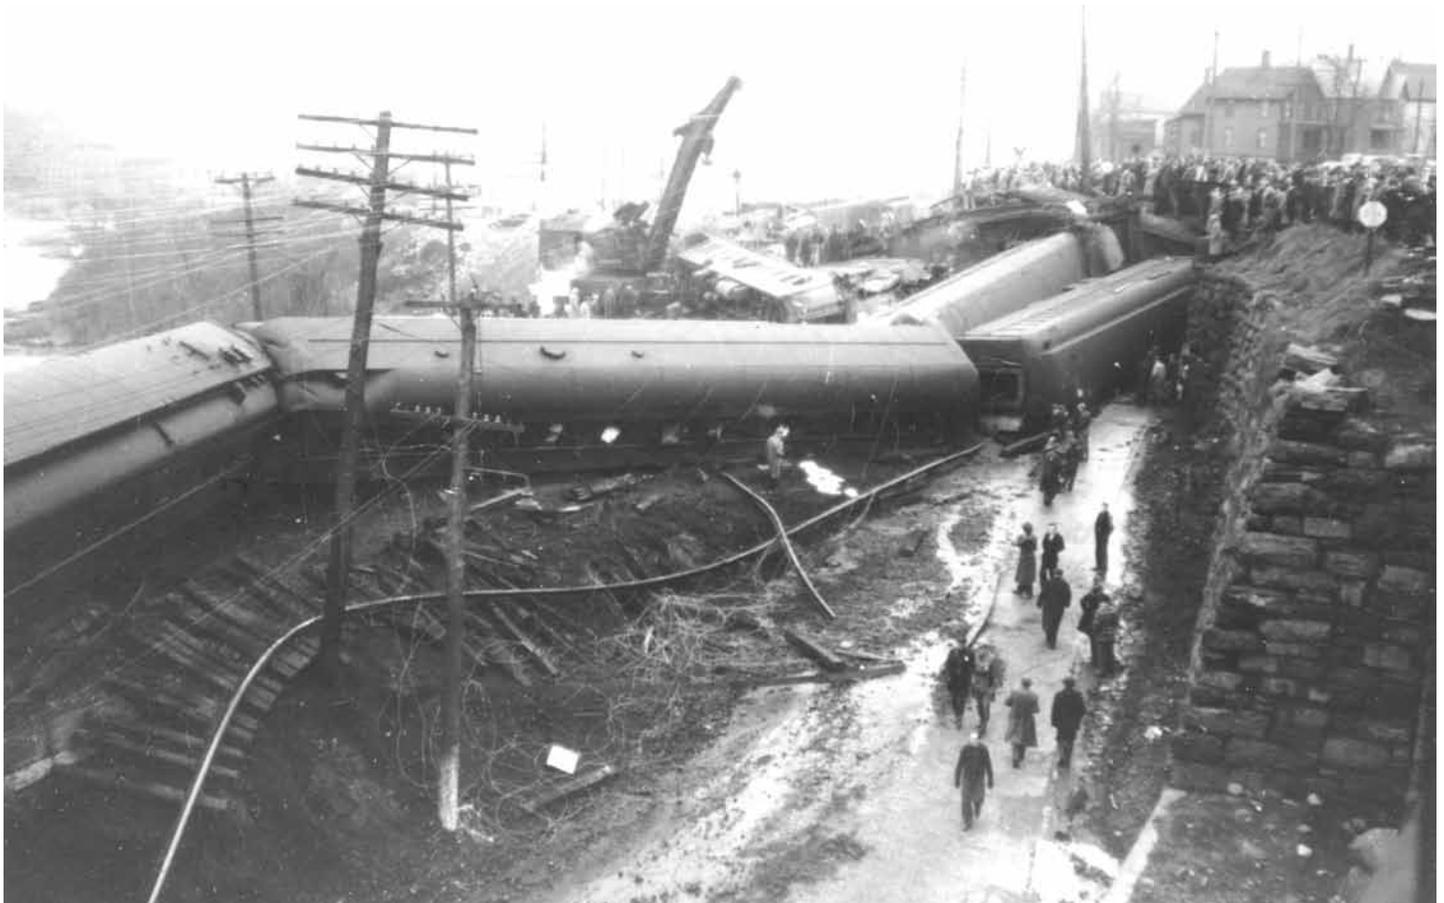
The third car, coach No. 2419, was launched across the freight mains and came to rest on its side, parallel to the express car. The following coach turned on its right side and slid up the adjacent East Main Street, passing beneath the Dolgeville Branch bridge.

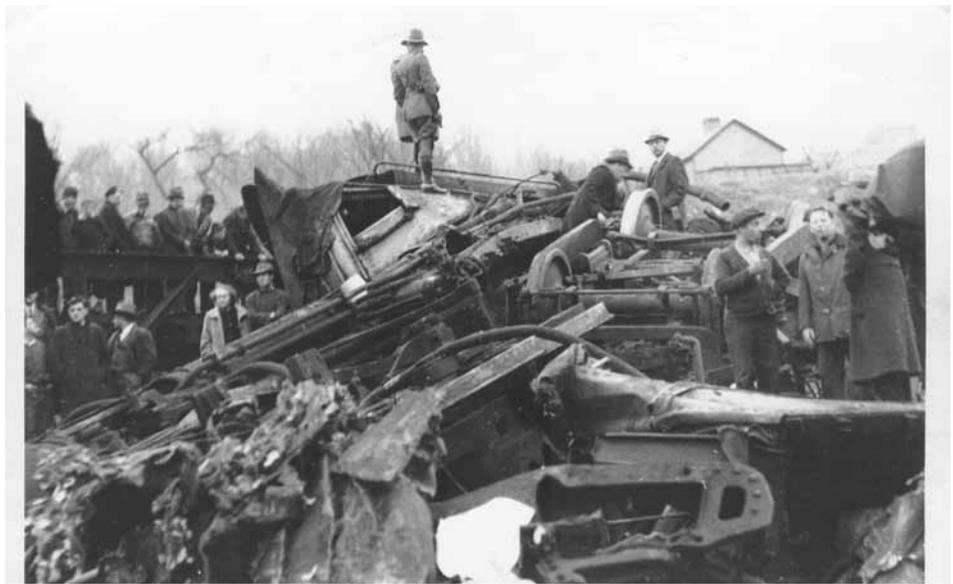
At top, rescuers at the scene were faced with a twisted mass of steel. Middle & bottom: the Pullman "Red Ash" remained upright, but its interior compartments were torn apart in the wreck. Gregorka Photo Service.

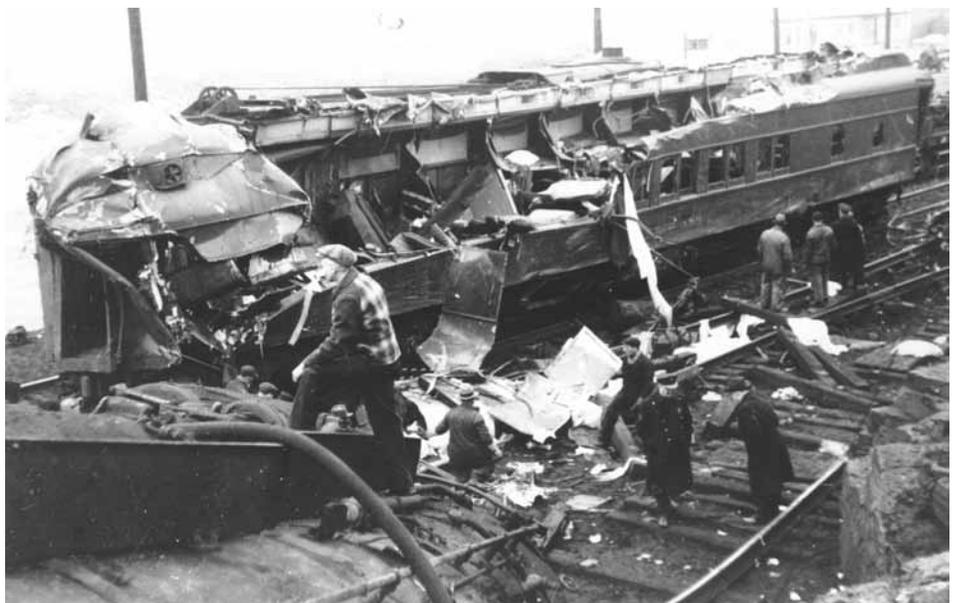
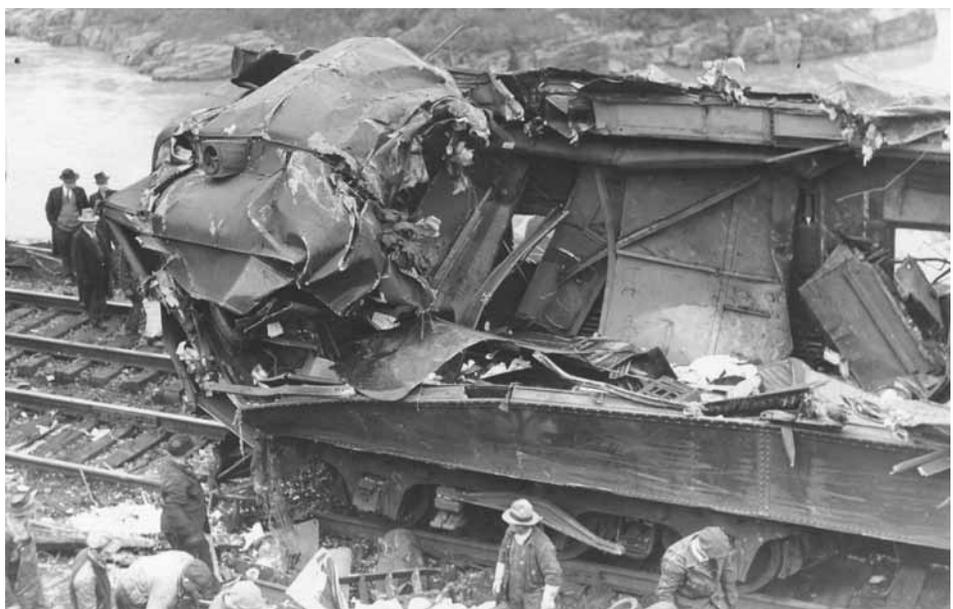
Uncoupled from the train, the *Red Ash* continued westward on Track 1, derailed but still upright. However, as it passed the pileup, the wreckage of the other cars sliced through its roof and right side, destroying most of the compartments. The sixth car, the Pullman *Poplar Arch*, rolled on its right side, and joined the stack of cars piled up against the engine.

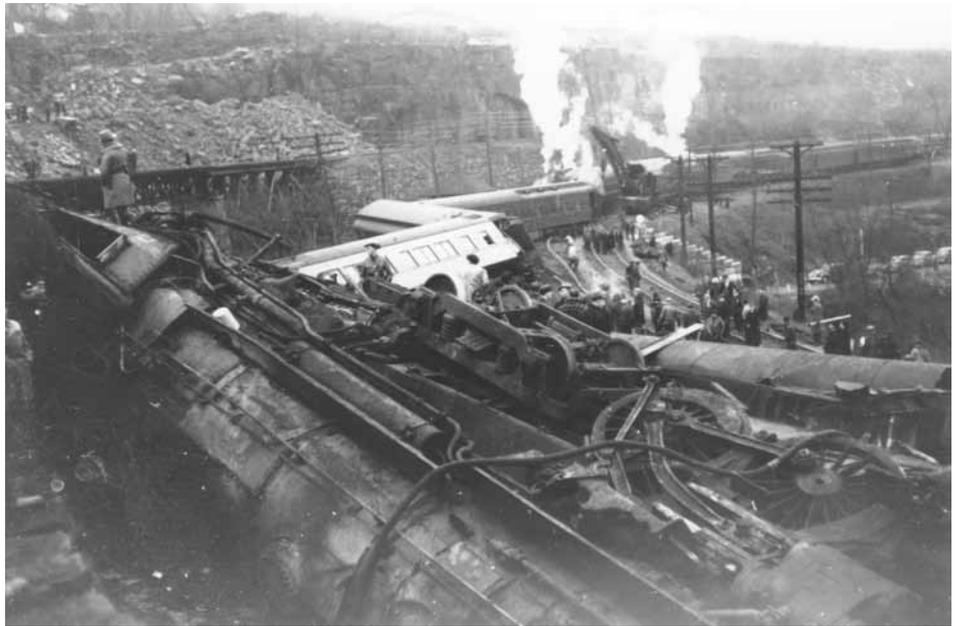
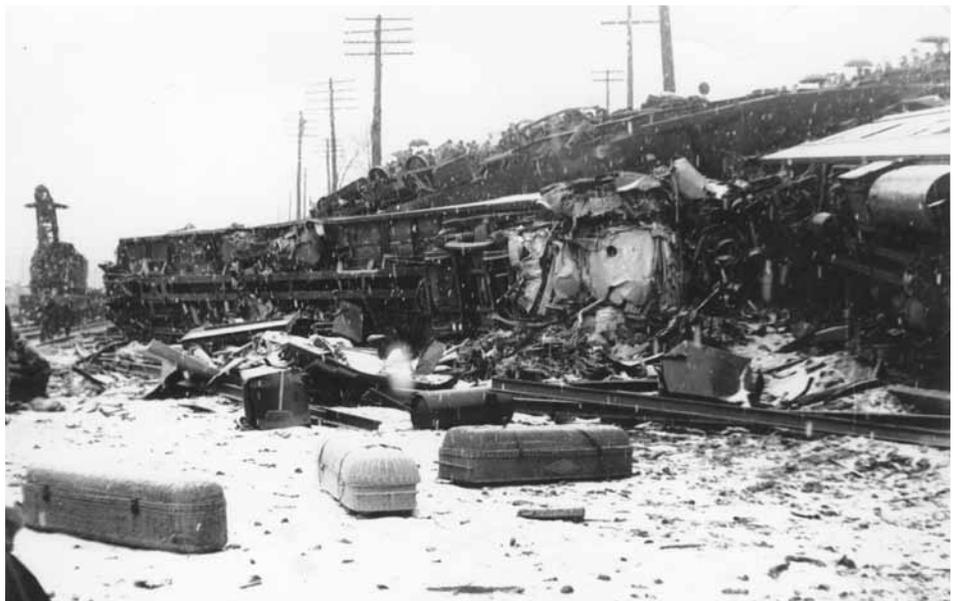
At right, the "big hook" arrives to rerail cars, while caskets of the 31 victims of the disaster are gathered. Both photos by Gregorka Photo Service. Below, two steam cranes work together to remove the tangled wreckage of engine 5315. Photographer unknown.
