# The Gulf Curve Disaster

Photos from the Collection of Harold Usyk

Story by David Hamilton

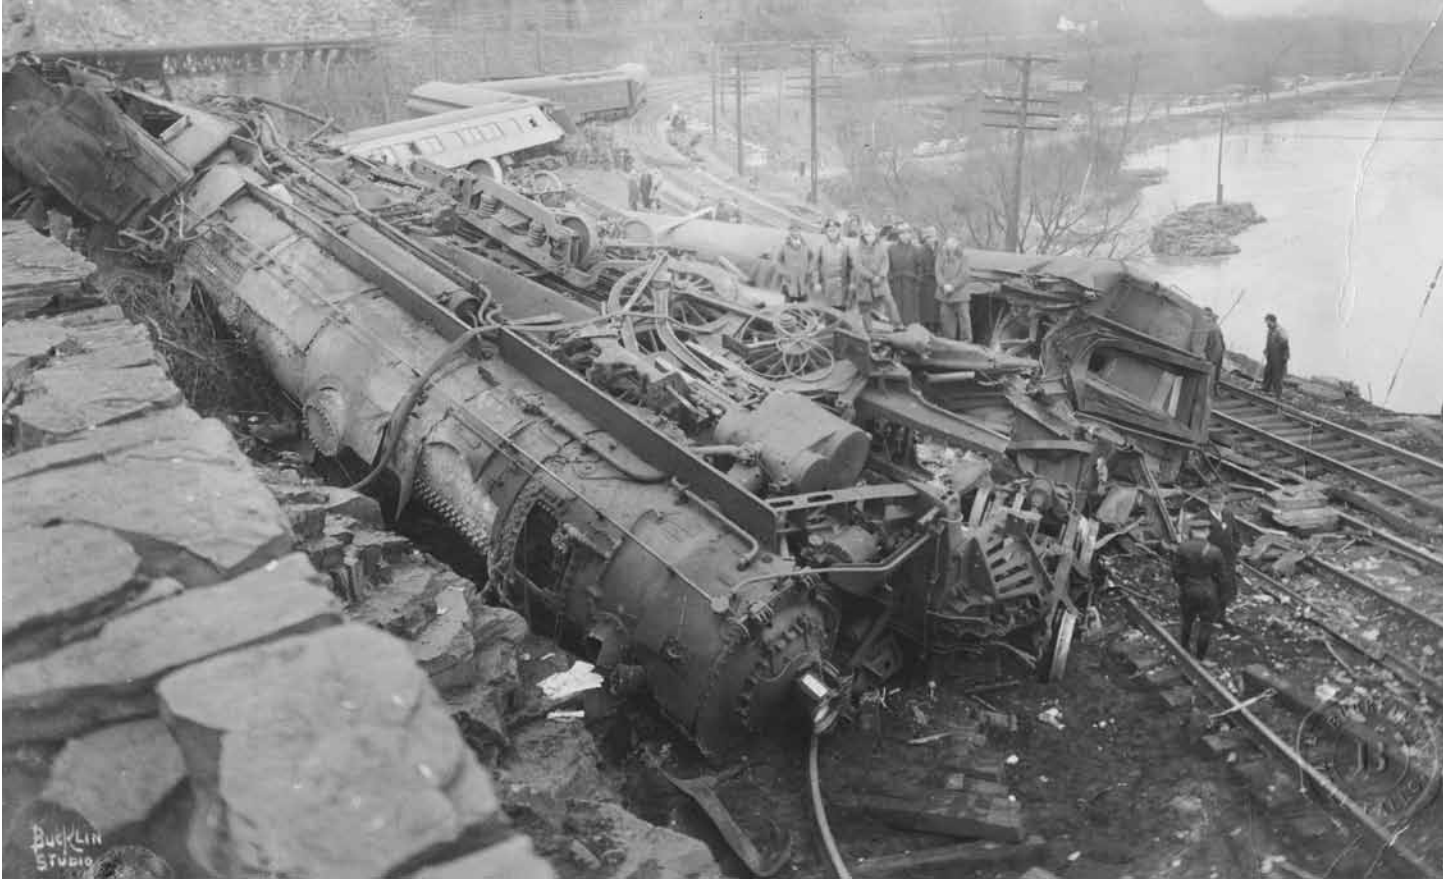
*The story of the Gulf Curve wreck is probably familiar to many Key, Lock & Lantern members, as it has been told in many books about train accidents, and the above photo by Bucklin Studio has appeared in various publications over the years. This particular print was contributed by Harold Usyk, whose collection also includes a number of photos of the wreck that have not been widely published in the past. He has been kind enough to share some of them with us on the next few pages. While we don't wish to reinvent the wheel with a lengthy account of the wreck, we have included a brief narrative of the deadly accident for those who have not read about it before.*

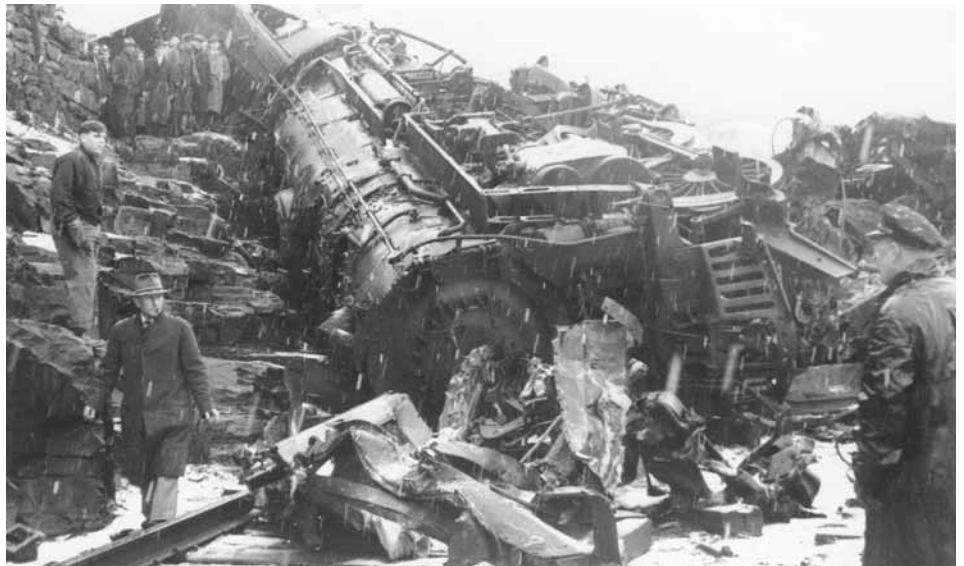
*At top right, Engine 5315 lies against the rock outcrop that stopped its northward slide. At center, a view of the wreckage of the cars that piled up against it. At bottom right, while recovery efforts continue, workers begin to repair the track. Gregorka Photo Service of Little Falls, NY.*

Rolling over on its right side, the engine slid across the two freight mains, until its momentum was checked by a small rock pinnacle that stood on the north side of the tracks. Sharp rock penetrated the firebox wrapper sheet, causing an explosion that blew out the crown sheet and grate bars, launching part of the ash pan across the river. The tender remained coupled and was deposited on top of the rocks.

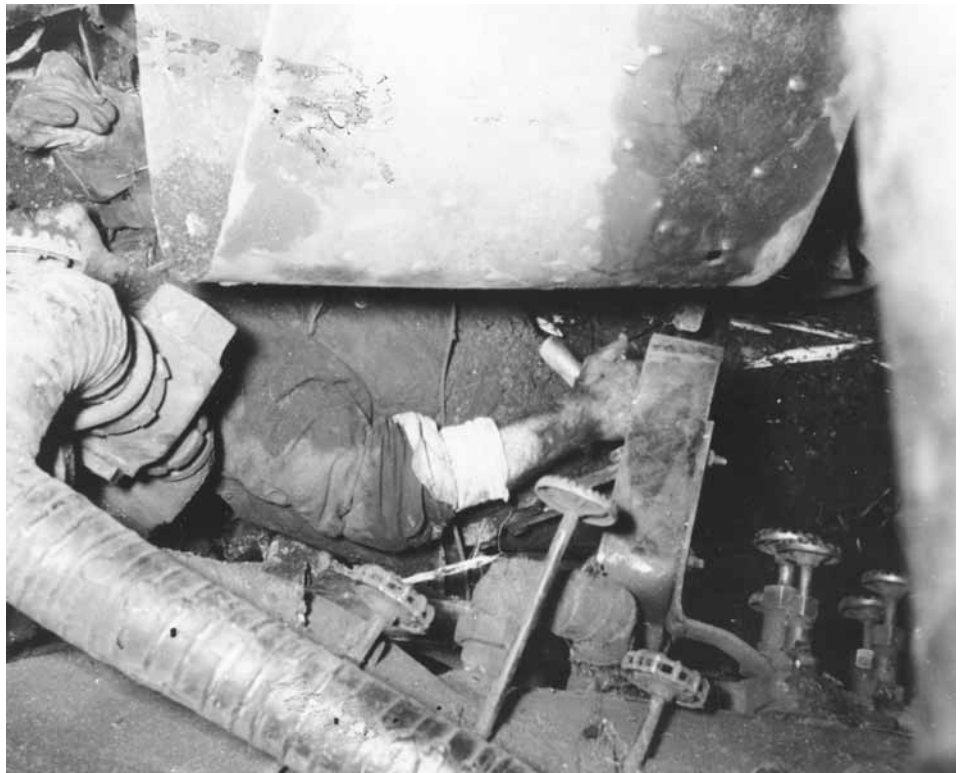
*Above, in a scene reminiscent of railroad folk songs, the body of engineer Jesse Earl lies pinned in the wreckage, with his hand still on the throttle. Below, a steam crane begins the process of righting the derailed cars, some of which slid up East Main Street. Both photos by Gregorka Photo Service of Little Falls.*

and others torn apart with their interior contents strewn about the tracks. The locomotive cab was crushed when it overturned and collided with the rocks, killing engineer Earl and fireman Smith. Road Foreman Bayreuther was seriously injured, but later recovered and was able to provide his account of the wreck to investigators.

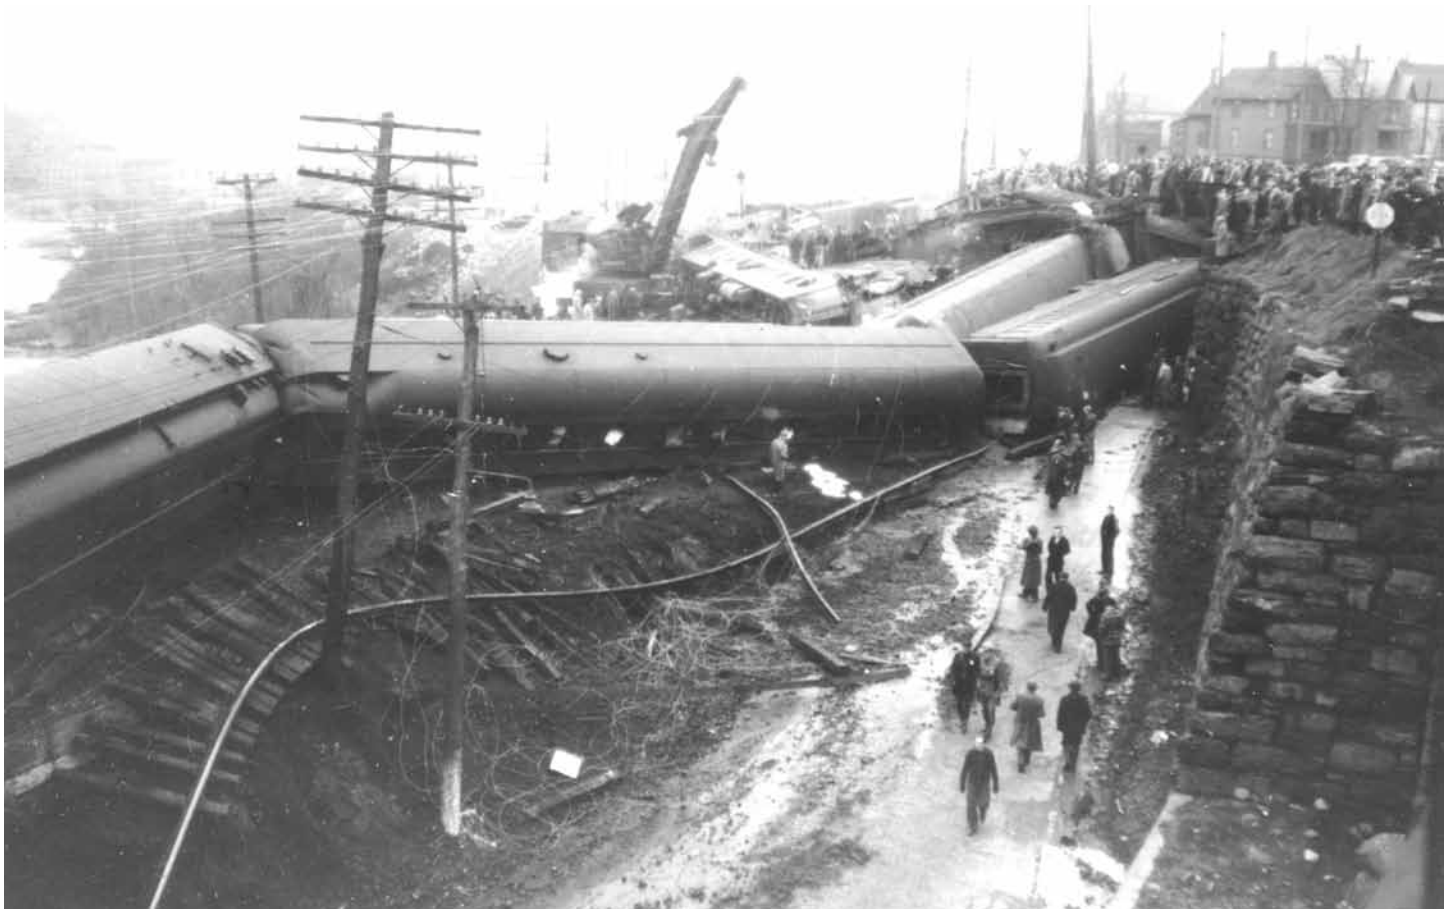
The third car, coach No. 2419, was launched across the freight mains and came to rest on its side, parallel to the express car. The following coach turned on its right side and slid up the adjacent East Main Street, passing beneath the Dolgeville Branch bridge.

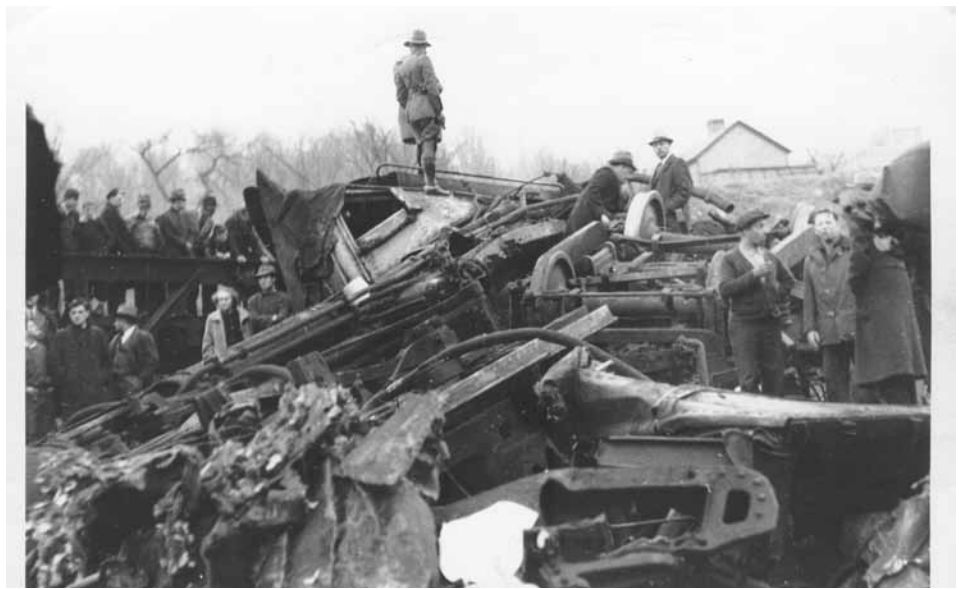
*At top, rescuers at the scene were faced with a twisted mass of steel. Middle & bottom: the Pullman "Red Ash" remained upright, but its interior compartments were torn apart in the wreck. Gregorka Photo Service.*

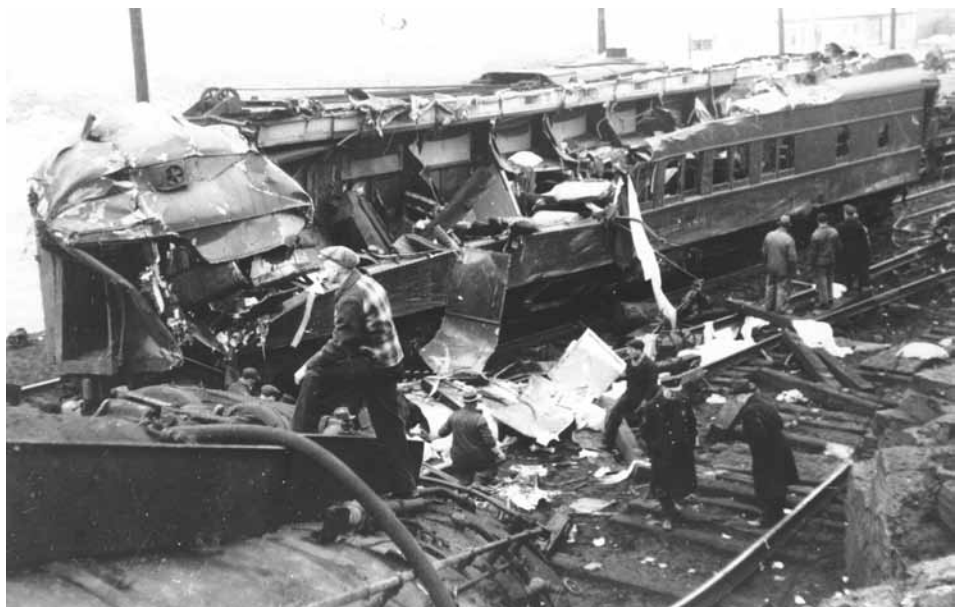
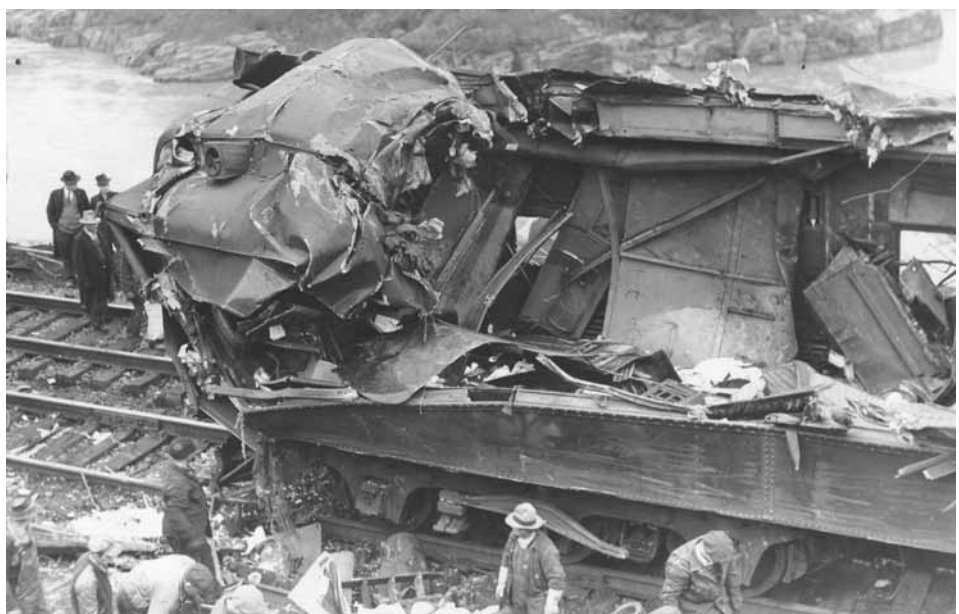
Uncoupled from the train, the *Red Ash* continued westward on Track 1, derailed but still upright. However, as it passed the pileup, the wreckage of the other cars sliced through its roof and right side, destroying most of the compartments. The sixth car, the Pullman *Poplar Arch*, rolled on its right side, and joined the stack of cars piled up against the engine.

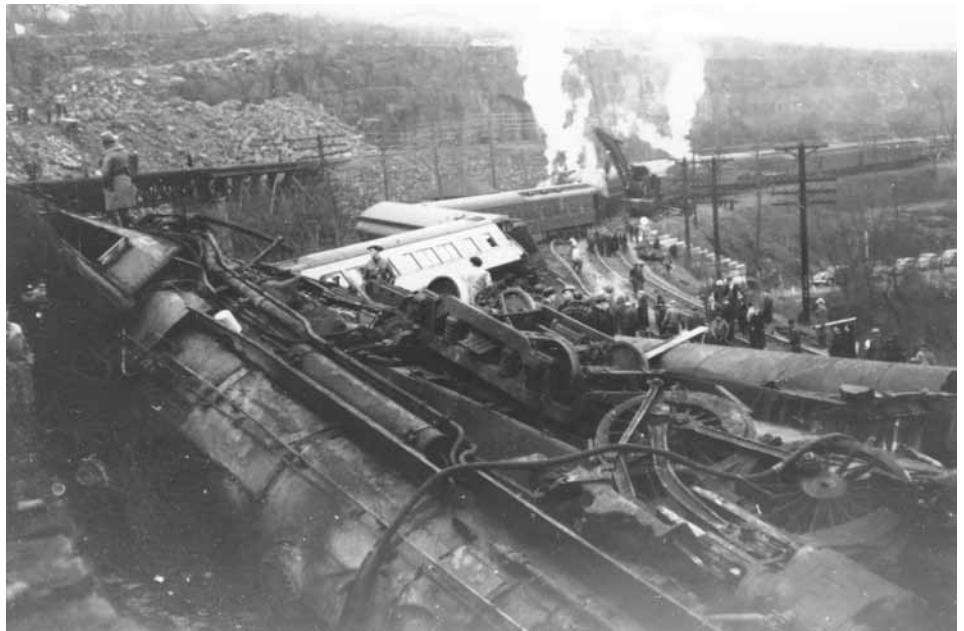
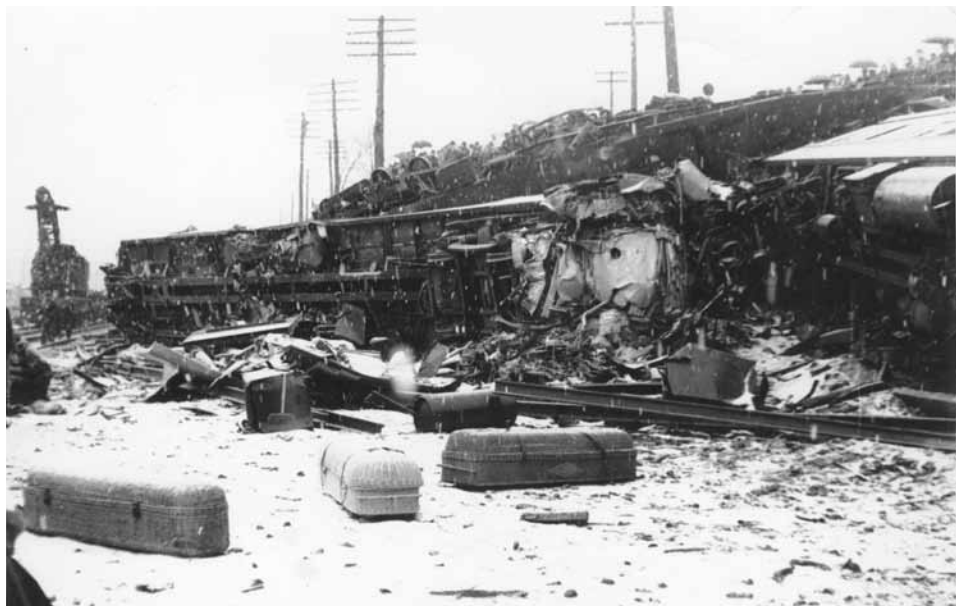
*At right, the "big hook" arrives to rerail cars, while caskets of the 31 victims of the disaster are gathered. Both photos by Gregorka Photo Service. Below, two steam cranes work together to remove the tangled wreckage of engine 5315. Photographer unknown.*
