The Gulf Curve Disaster

Photos from the Collection of Harold Usyk

Story by David Hamilton

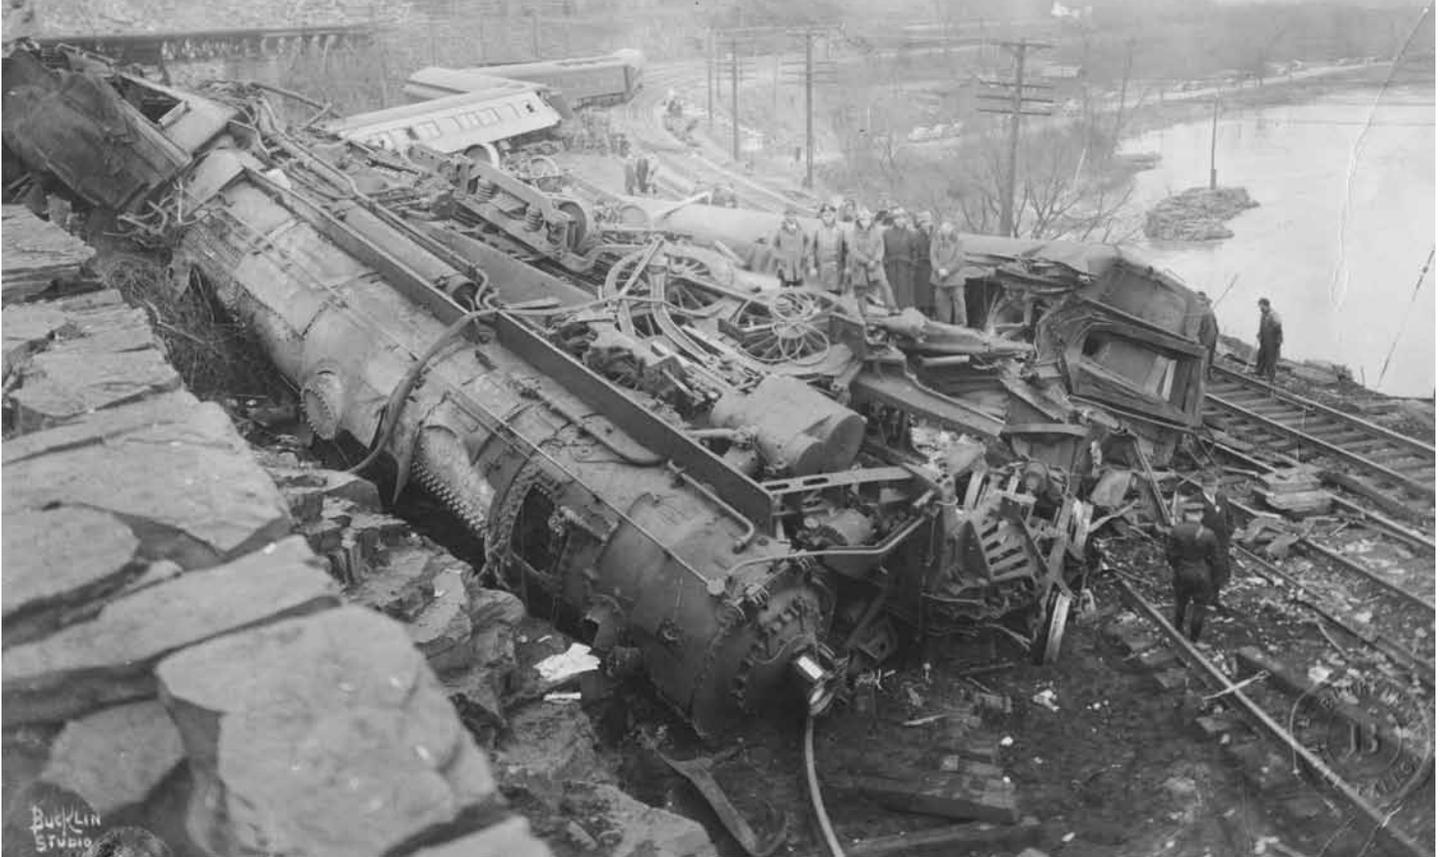
The story of the Gulf Curve wreck is probably familiar to many Key, Lock & Lantern members, as it has been told in many books about train accidents, and the above photo by Bucklin Studio has appeared in various publications over the years. This particular print was contributed by Harold Usyk, whose collection also includes a number of photos of the wreck that have not been widely published in the past. He has been kind enough to share some of them with us on the next few pages. While we don't wish to reinvent the wheel with a lengthy account of the wreck, we have included a brief narrative of the deadly accident for those who have not read about it before.

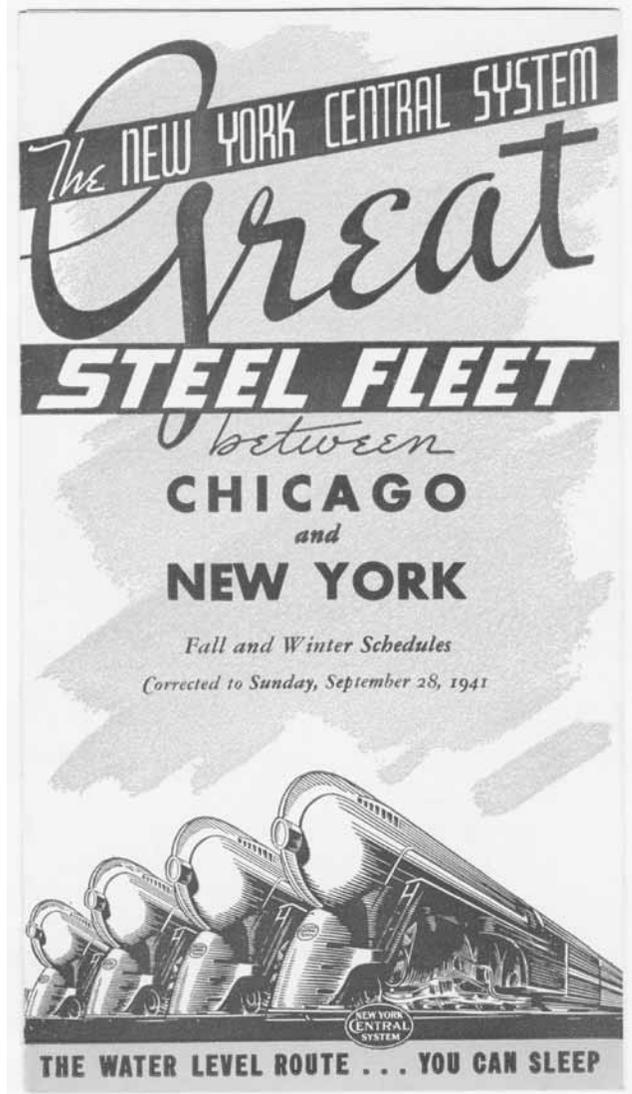
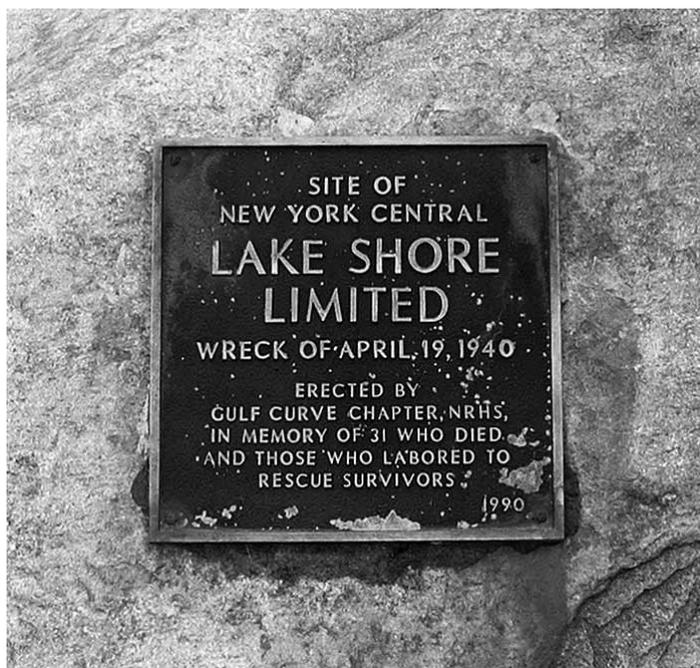
In 1947, the mainline through Little Falls was realigned, in a project to eliminate the sharp curve. The entire course of the Mohawk River was changed by blasting out rock on its south bank, and filling in the elbow that originally necessitated the construction of the curve. Today's Gulf Curve is a sweeping one degree, thirty minute spiral that doesn't require a speed restriction, although passenger trains must still slow to 55 MPH for other curves located immediately to the west.

The alignment of the original Gulf Curve is still visible from passing Amtrak trains, although it is has become increasingly obscured by vegetation in recent years. In addition, modern highway construction has brought about many changes to the area, and the location of the wreck is hardly recognizable today. However, a small monument erected by a local NRHS chapter at the intersection of Route 5 and River Road still serves as a reminder of the events of that tragic night.
